Project No. 1383-001-00
Document No. 09-0060

SUBJECT: REPORT OF GEOLOGIC RECONNAISSANCE

Pine Valley TPM 20765 RPL-2
Old Highway 80
Pine Valley, California
APN 410-010-07 and 410-030-20

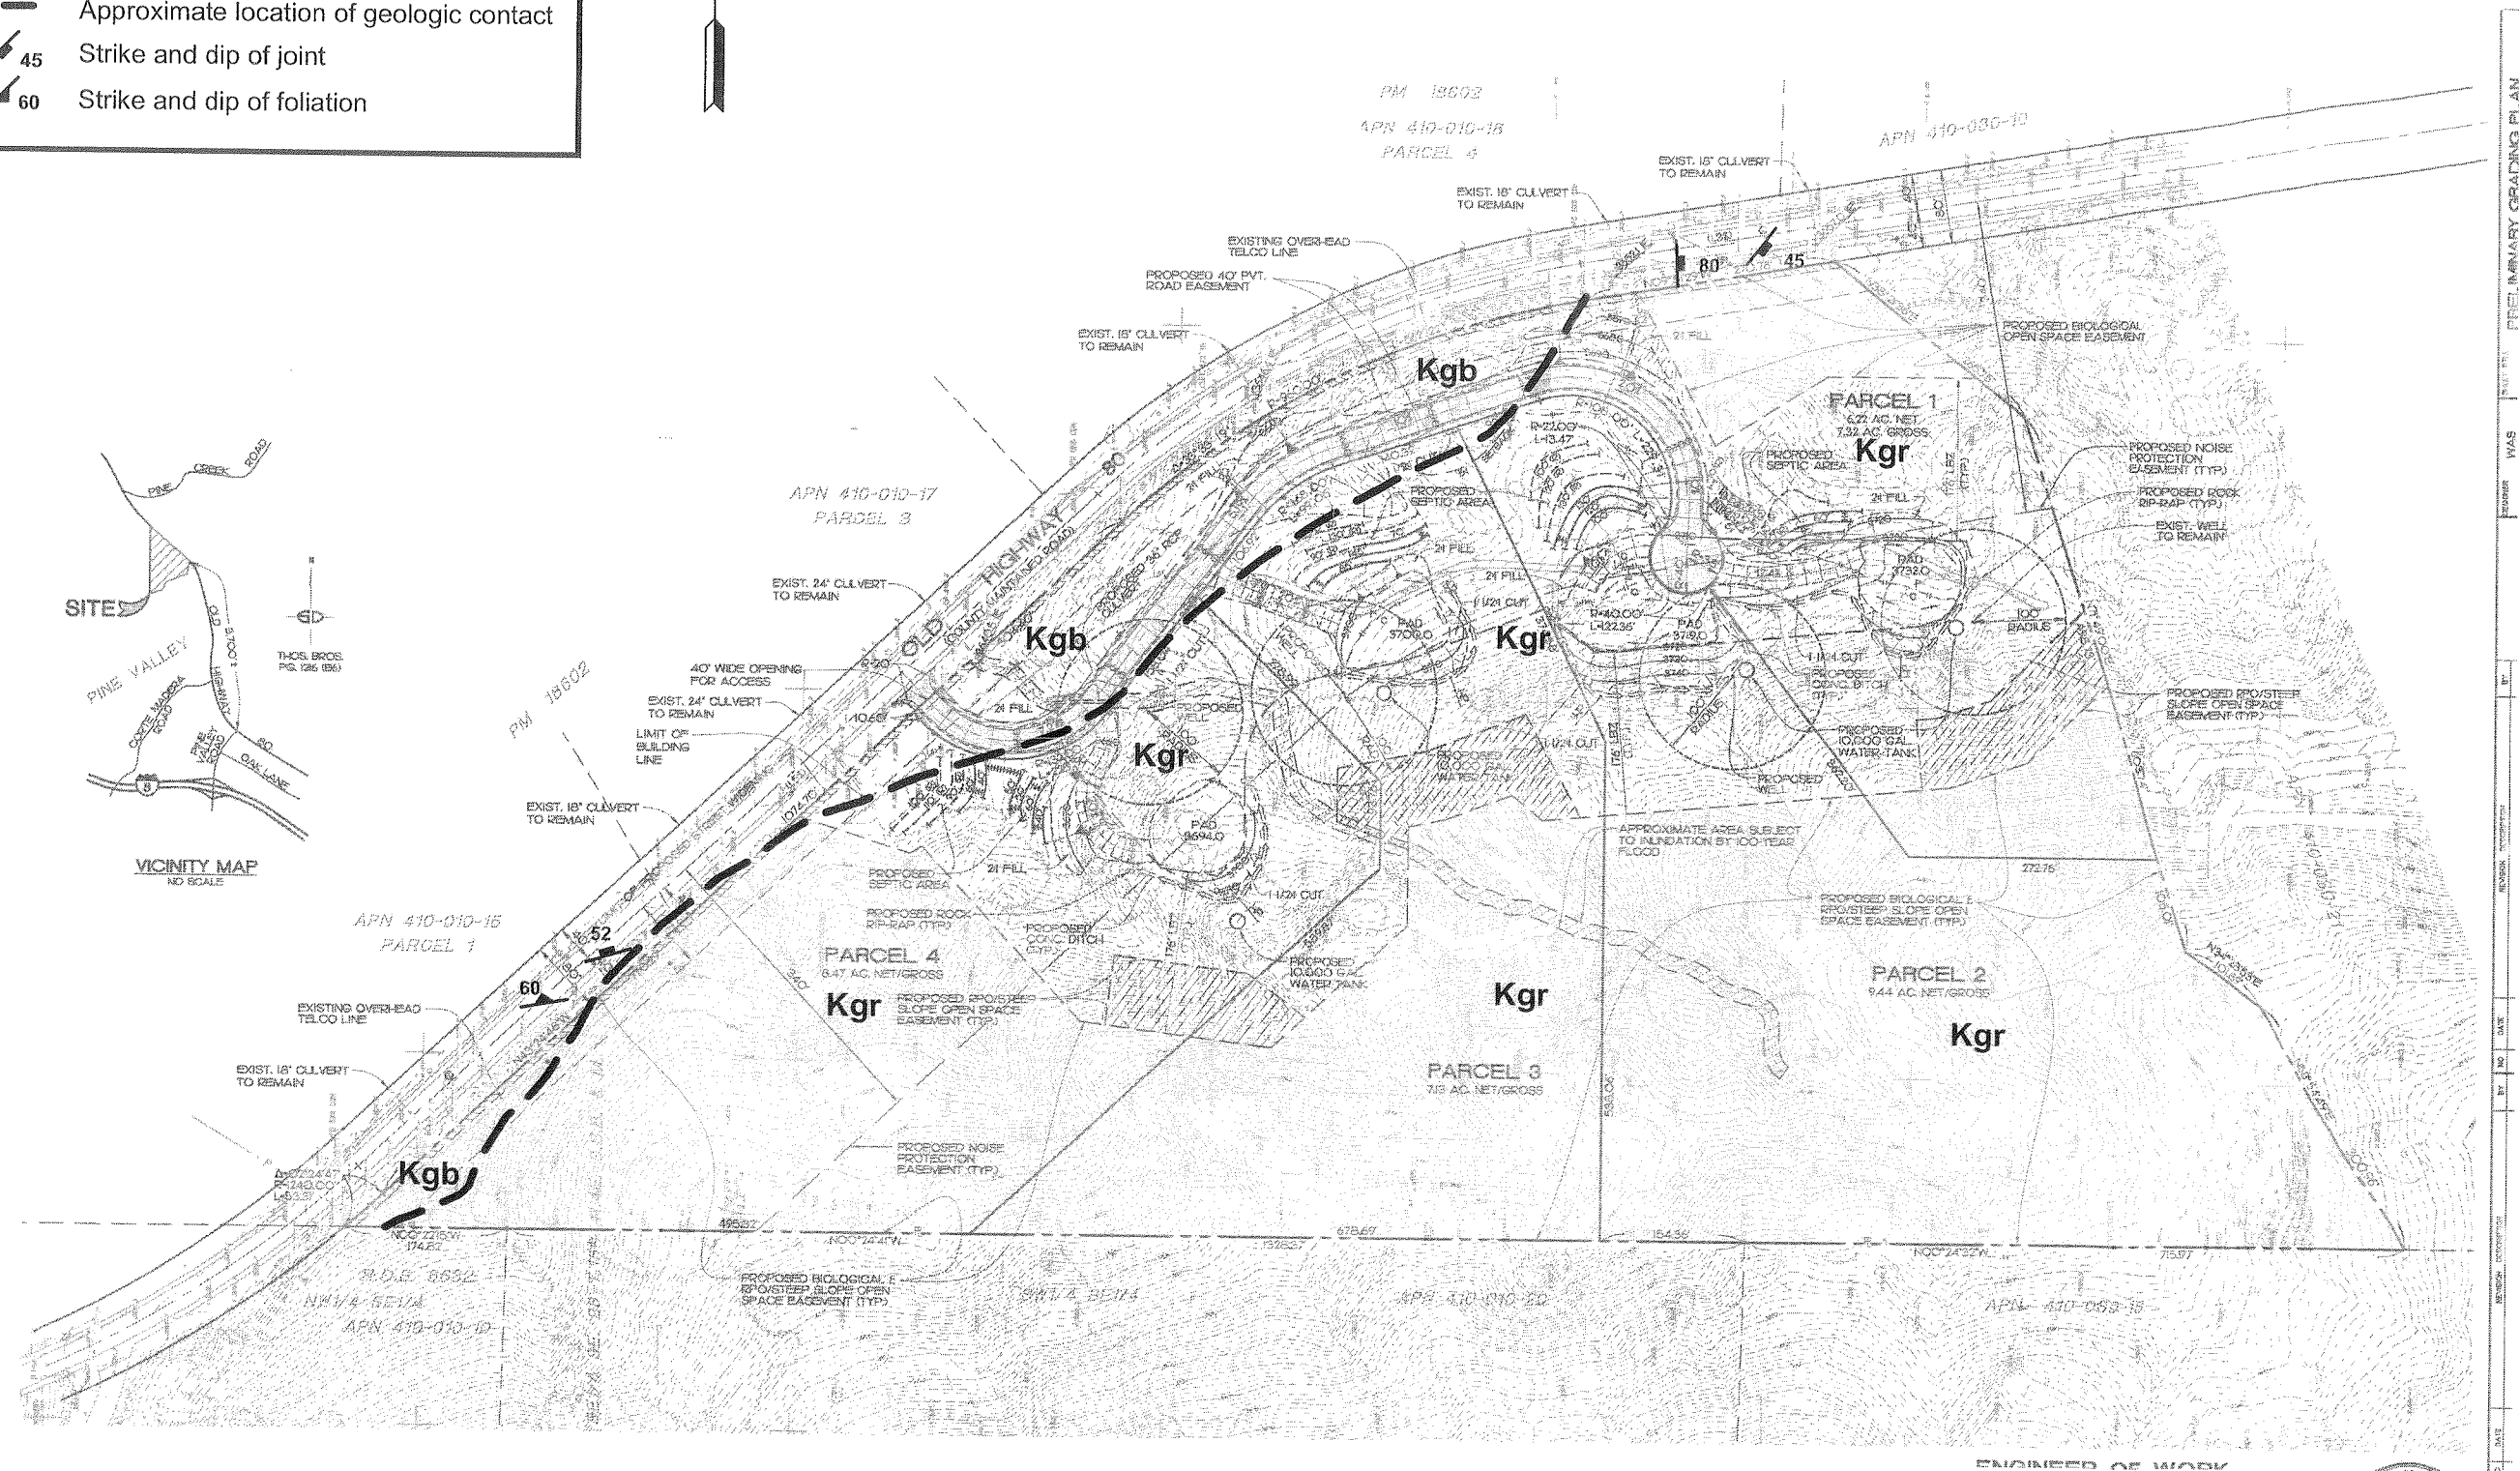
The site is located in the mountain ranges around Pine Valley, California. As observed during our reconnaissance, the site is underlain by two different types of crystalline batholithic rock covered by variable thicknesses of residual soil and colluvium. The geology is shown on the Geologic Map, Figure 2. Generalized descriptions of the geologic units observed at the site include:

Granite underlies most of the property and the ridge overlooking the site to the west. The rock is coarse grained, massive but jointed and widely spaced. There are two prominent joint sets at the site; north-south and east-west, both dip steeply (Geologic Map, Figure 2). Outcrops of the rock are typically light brown to yellowish orange, and have slightly to moderately weathered faces. There are few large corestones at the higher elevations west of the property. On the property, the outcrops and relatively flat and rocks are well seated in the surrounding weathered material or soil. The rock appears to be associated with the early-Cretaceous Pine Valley Monzogranite described in the Preliminary Geologic Map of the El Cajon 30' x 60' Quadrangle (USGS, 2004). The weathered rock material classifies as fine to coarse grained silty sand (Unified Soil Classification: SM) and poorly graded sand with silt (SP-SM). The weathered rock is light brown to reddish brown in color, commonly iron
